Manhole Inspection Summary

Manhole # S13UU_012MH

Location Address: **3000 LIBERTY HEIGHTS AVE**

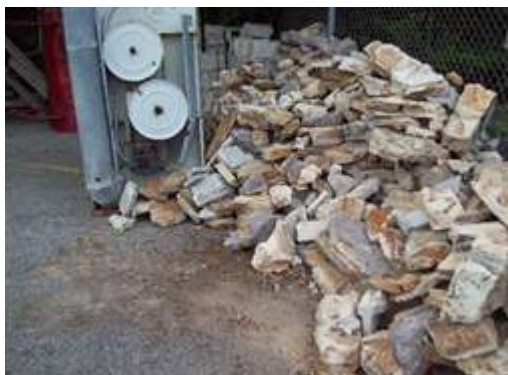
Cannot Access - Buried - Debris from Junkyard and Construction on Top of the MH

Comments **CAN NOT ACCESS PRIVATE PROPERTY MH HAS A LOT OF ROCKS PILED ON IT SEE PICTURE**

ROCKS ON MH
